## TECHNICAL SERVICE BULLETIN

Product: Spire 1.1 Tower

Subject: PIR Pin Interference with protective cover

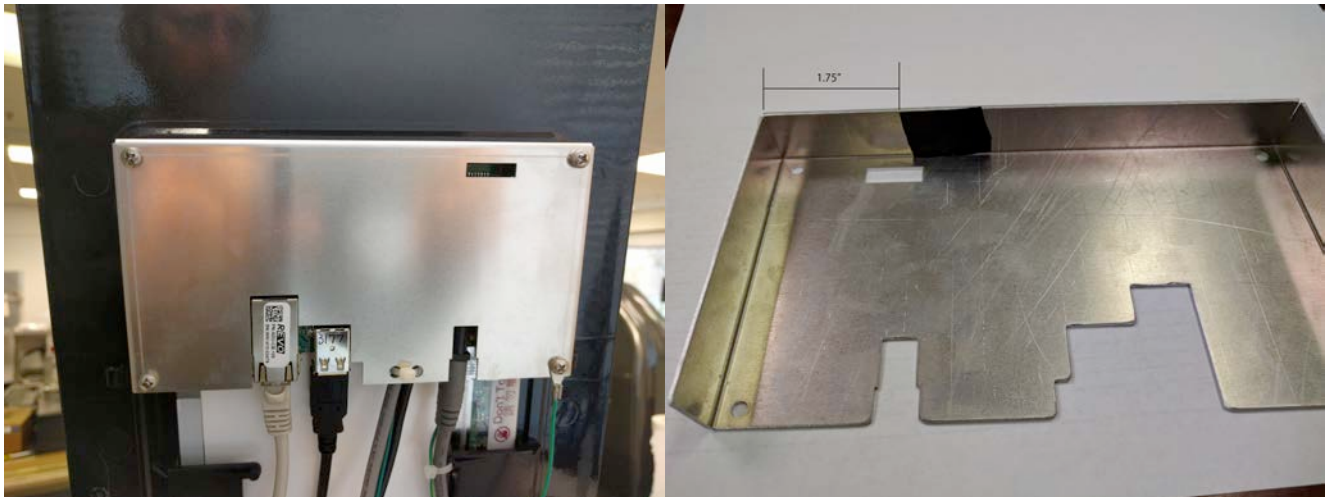
Screen fails to power on and ADU power LED is not illuminated with 5 volts (+/- 0.25 volts) being measured at the ADU input.

1. Power off the unit and unplug it from the outlet.
2. Remove rear cover
3. Fully remove metal shield behind display by removing screws and cutting wire tie.
4. Place 1" long piece of 0.75" width electrical tape (Scotch Super 33+) 1.75" from the left side of the shield as shown in the picture above. Make sure to wipe down the metal surface before placing the tape.
5. Re-install metal shield making sure to attach grounding wire and wire tie as shown in picture above.
