# Wunder-Bar™

## TECHNICAL SERVICE BULLETIN (REVISED)

Product: All Bar guns – Standard and Flow Regulated

Subject: Possible Leaking Heels Due to Stack Up Tolerance of Barrier Tubing

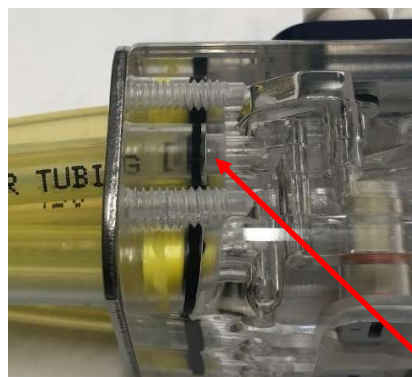
When the barrier tubing is on the low end of the manufacturing tolerance, there is the potential for inadequate compression of the barrier tube cap into the Bar gun handle, which could result in a slow drip.

Area where a leak may occur

Handles are now machined where the large barrier tubing holes are shallower in depth to allow for adequate compression where the large barrier tube cap and O-ring meet.

Bar guns with a manufacturing date of 09/17/2019 and older that exhibit a leak should be submitted through the normal RMA process either directly with Wunder-Bar or the distributor you purchased your Bar guns from.
