Wunder-Bar™

TECHNICAL SERVICE BULLETIN

Product: Bar-Gun Manifold

Subject: Cracking Manifold (**Potential Failure Due to Poor Manifold Frame Structural Integrity**)

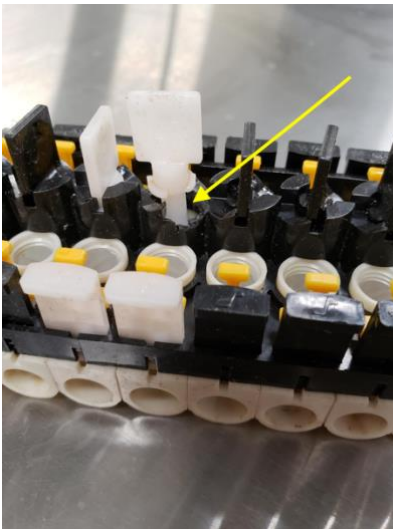
Special attention should be placed on the shut-off screw and surrounding frame region. If either of these are damaged or bent, the frame may crack and open a pressurized water or syrup line. Any sign of bending at the shut-off spade (finger hold on top of the shut-off) may be an indicator that the shut-off has been twisted beyond its normal limits and may have translated a crack to the frame.

Catastrophic blow out, typically located in the center of the manifold where higher pressures develop.

Review for Cracks and/or breaks & replace per instructions. Document manifold and contact Wunder-Bar for replacement.

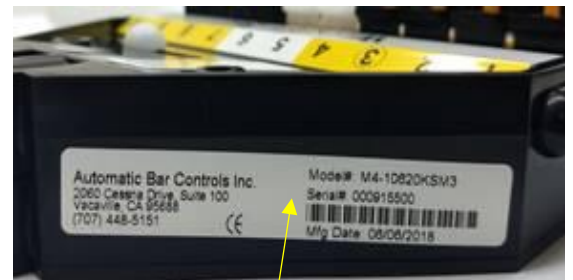
Serial Number Identification

Serial Numbers between – 000901759 - 000958207
